Green Infrastructure on Private Properties in New York City

Sustainable Stormwater Management Program of the
New York City Soil & Water Conservation District
2010

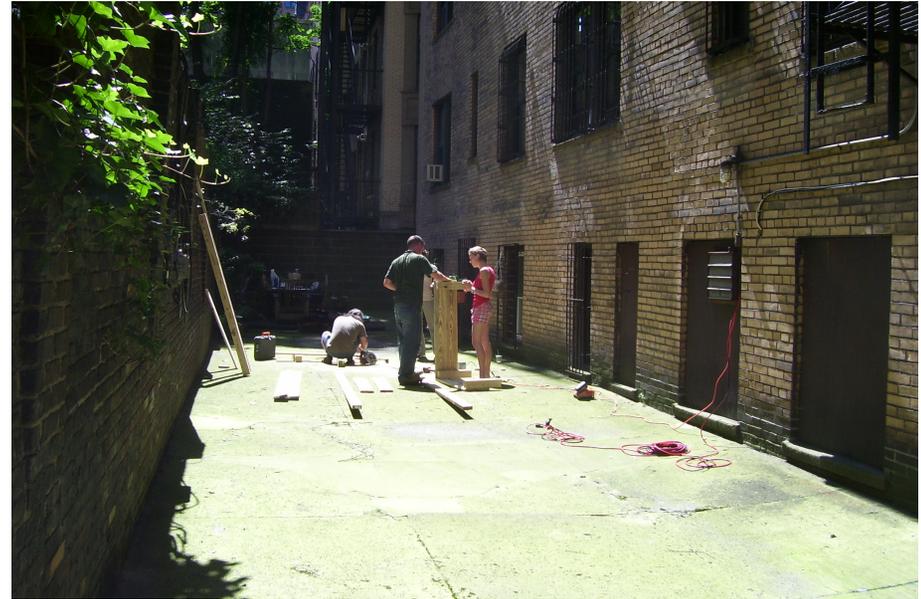
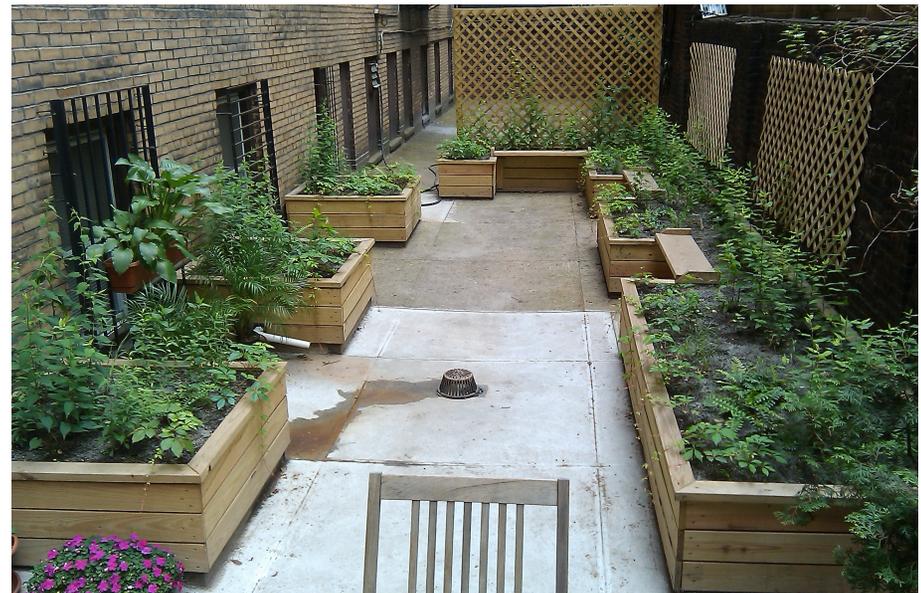
Above: the project site before construction had very little greenery. Below: three small planters and one large planter were constructed. The large planter has integrated benches. All plants are native shade tolerant species. Far left: Blue wood Aster thriving in a planter.

eDesign Dynamics developed a “greenroof on the ground” design with custom built lined planters with overflow pipes. Three of the four planters are 4' x 4' x 1.5'. The largest planter is L-shaped with a total length of 30', with the elbow of the L being 10'. It has the same width and depth. We lined all the planters with geotextile and pond liner and placed a perforated 1.5” PVC pipe on the bottom as drain pipes, which were connected to a vertical PVC pipe of the same diameter on the outside of the planters.

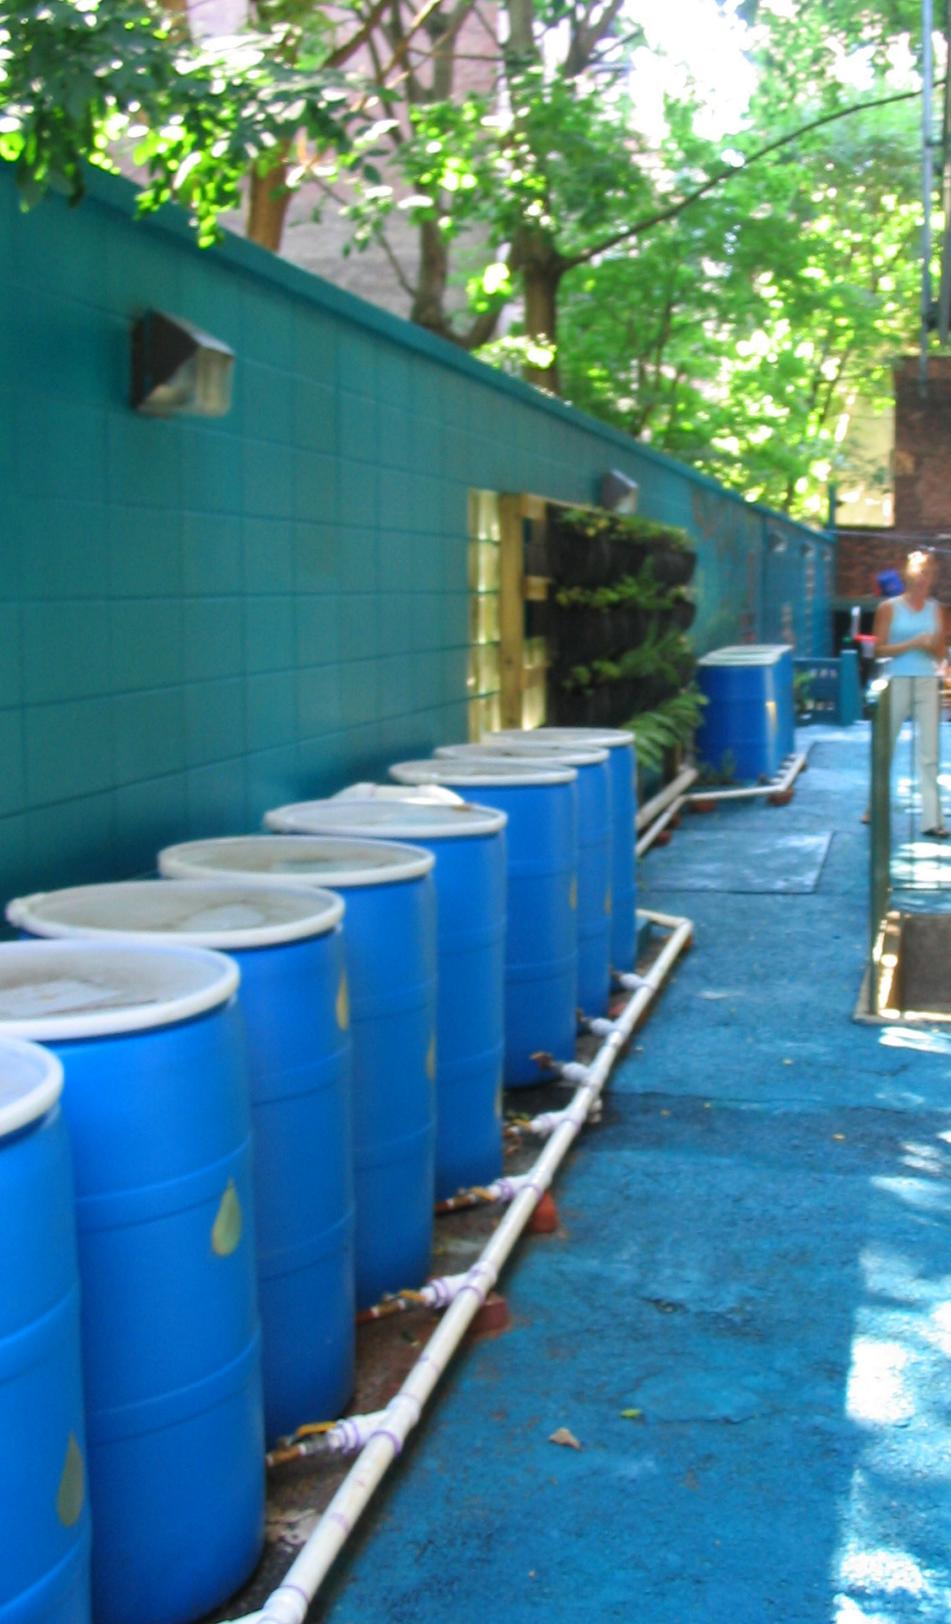
Above: twenty barrels were connected in a series as shown in the schematic. The last barrel furthest from the downspout was designed to be a rainwater harvest barrel without a low flow orifice. Below: a plan view of the project site. Far left: beyond installation of the rain barrels and the green wall, the project team incorporated educational elements. A mural depicting non-point sources of pollution and plants as water purifier was painted. The ground was also painted to depict water to reinforce the importance of water to our lives (see cover photo).

The existence of an external downspout, draining a roof approximately 4,000 square feet, prompted eDesign Dynamics to develop a detention system consisting of twenty rain barrels connected in series. Because the site gets very little sun and the ground is paved with the exception of the tree pits, we would not be able to plant enough vegetation for a retention system. However, to enhance the educational components of the project, the District

requested a green wall in the design, with one of the barrels as a rain water harvest barrel with a spigot.

The green wall was installed using Wally Pockets fastened to a wooden frame. Because the ownership of the wall was unclear, we decided not to install the Wally Pockets directly to the wall. We installed eight pockets across in four rows and planted three species of native ferns and the Virginia Creeper.

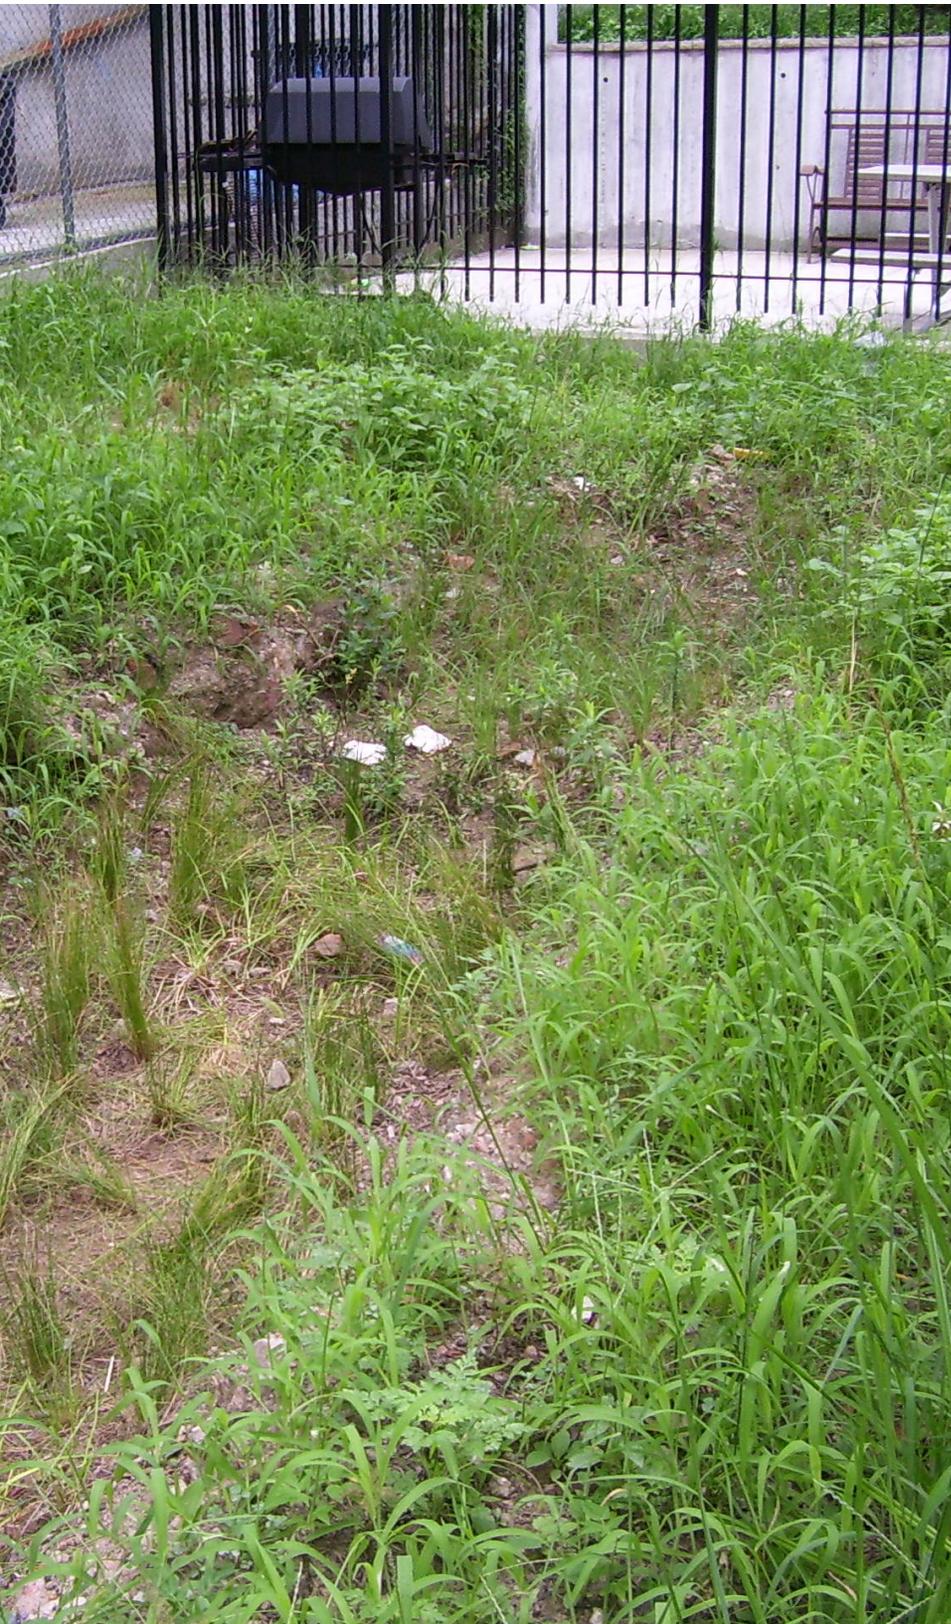
Above: 2" plugs were planted into holes with a mixture of native soil and mulch. The site was irrigated for several weeks. Below: by October, most plants were thriving. However, small patches of mugworts were also returning. The barrel in the middle is a sump that controls the flow of rainwater from the rain barrels outside the fence. Below right: after a rain, the ditch is filled with rainwater, which infiltrates into the ground. When the sump signals the maximum volume, a valve shuts off the flow to the sump and barrels begin to fill. When both the wetland and barrels are at capacity, the flow is diverted back to its original course (directly into the sewer system).

The lot is set back from the street, flanked by an L-shaped private park belonging to the adjacent building. The lot is also below grade level from the sidewalk. Because we could not access the lot directly from the street, we were unable to use earth moving machinery. Thus, excavation was done manually with the staff from the project team and volunteers. This also meant that we were not able to either replace the soil or bring in new top soil.

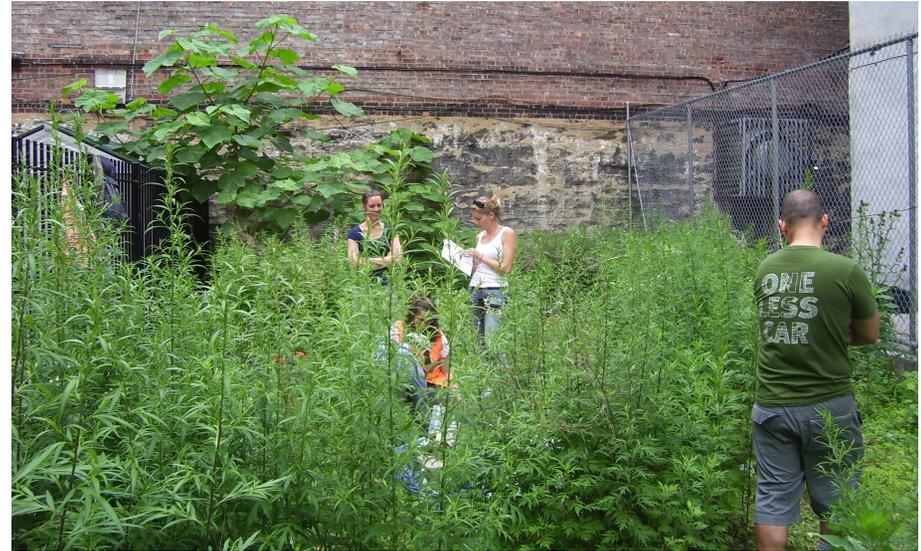
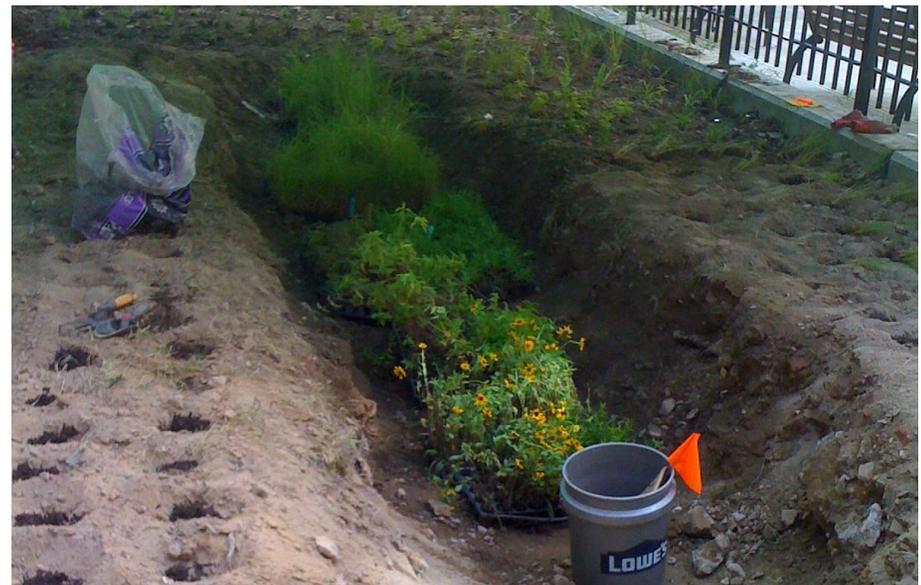
Above: the site was infested with Mugworts nearly five feet high and strewn with trash. Below: after weeding, a ditch was dug out for a wetland. Holes on the left were dug with a jackhammer. Because of the location of the site, removal of the top layer of soils was not possible. Far left: the site was planted with all native species. Inside the ditch, wetland species were planted.

A ditch approximately 3' wide, 2' deep and 54' long (approximate volume = 2,400 gallons) was hand dug and planted with wetland species. At the north end of the ditch, we placed a perforated rain barrel as a "sump" connected to the series of rain barrels fed by the roof drain. Barrels are filled in series starting from the one closest to the roof drain. When all barrels are full, excess water is routed to the ditch. When the water reaches the maximum level inside the ditch, the float inside the sump triggers a shutoff valve, routing any additional excess water to drain directly into the original drain pipe connected to the sewer system.
